L1970450003 – Will  
Carlstrom Landfill  
ILD 980497721  
SF/HRS

**CERCLA  
EXPANDED SITE INSPECTION REPORT**

**Carlstrom Landfill**

**September 9, 2004**

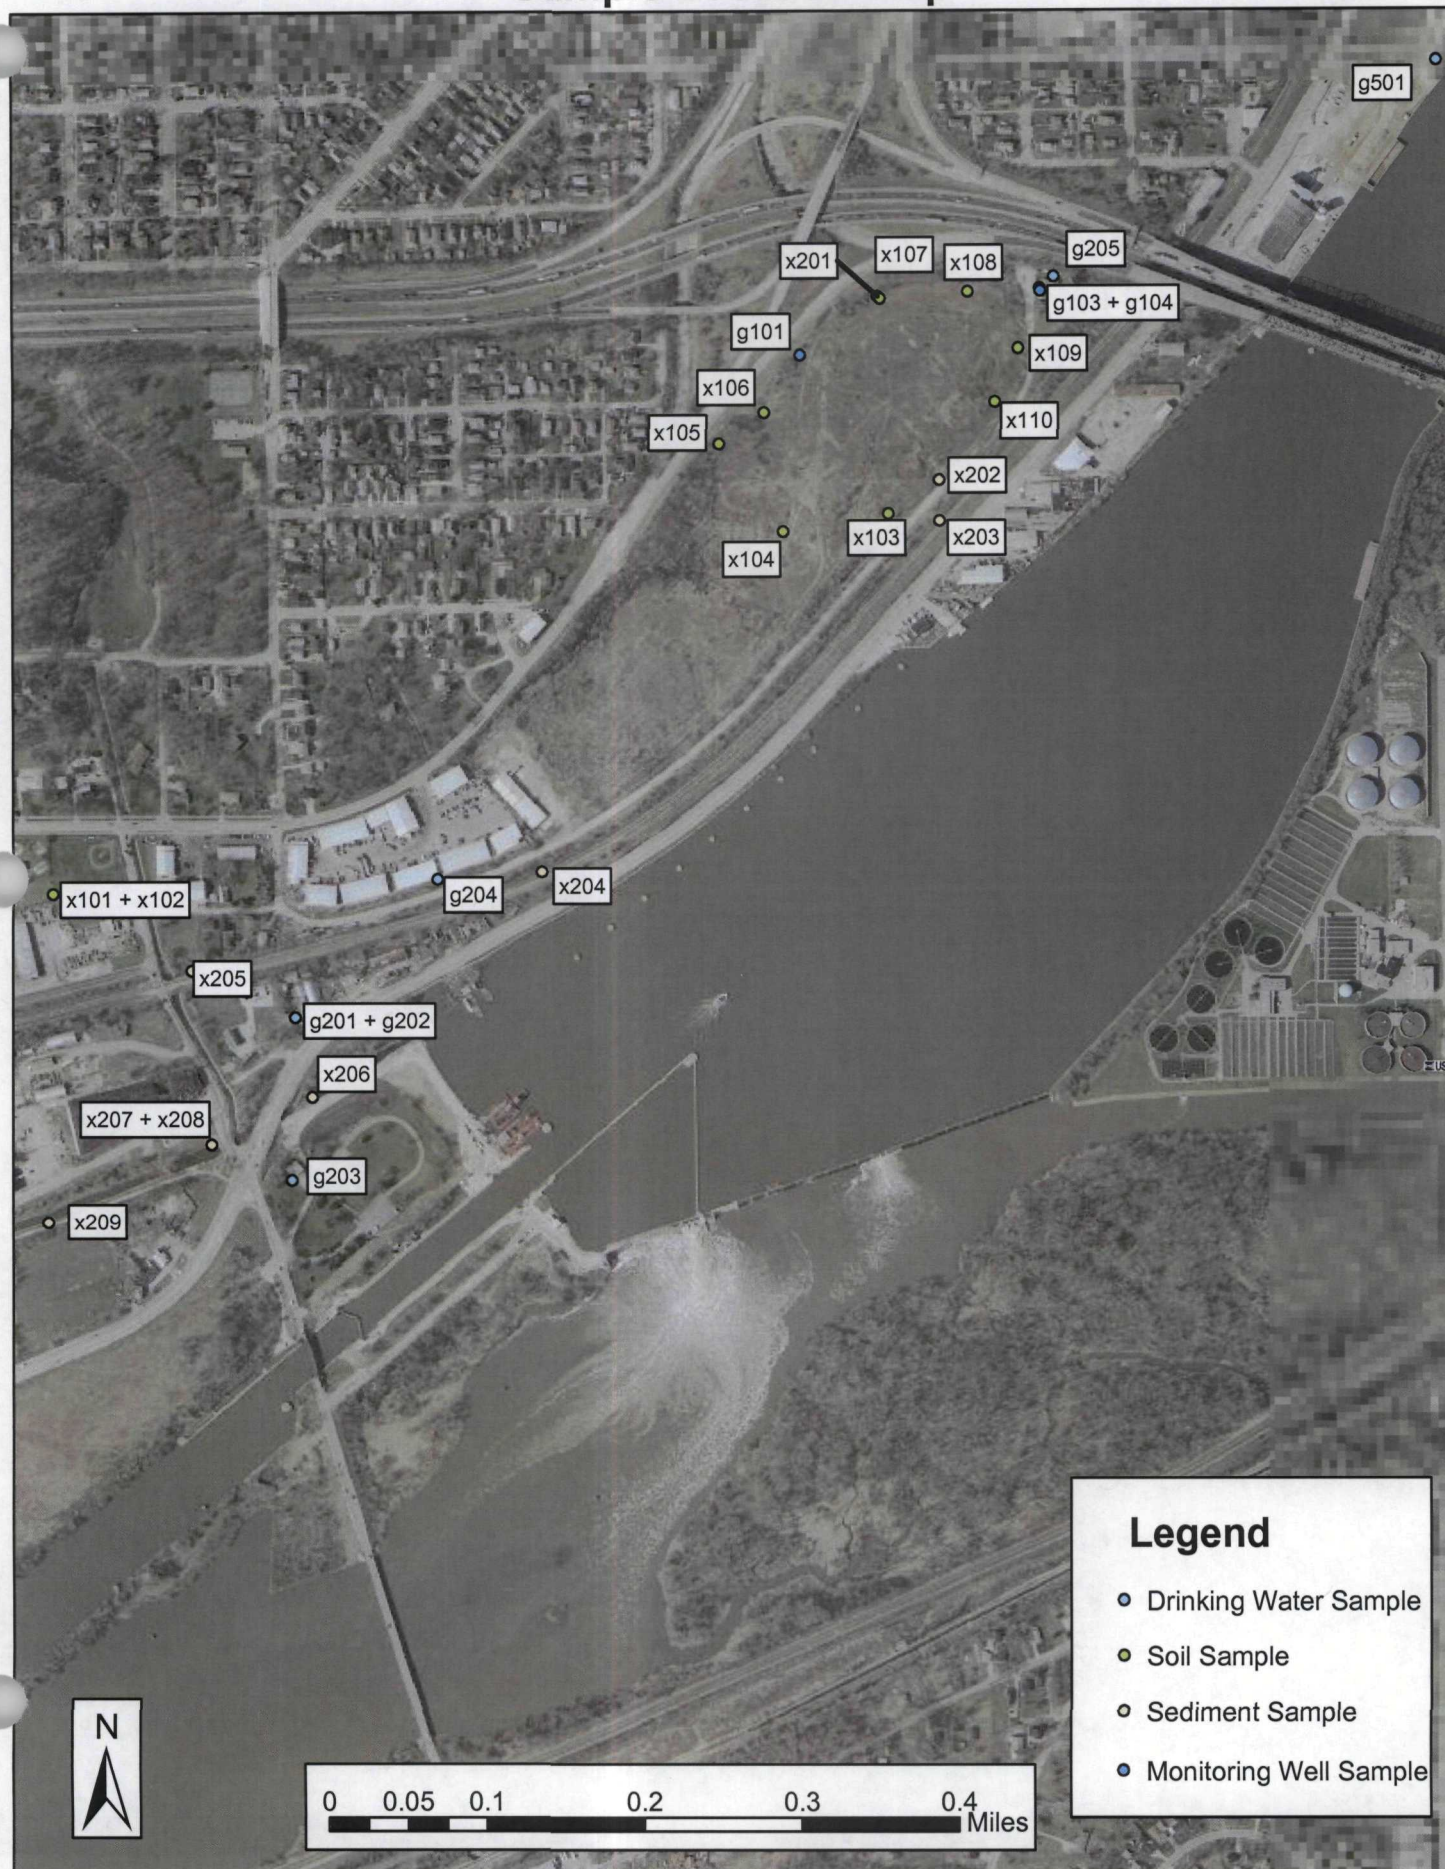
**Figure 4**  
**Carlstrom Landfill**  
**Sample Location Map**

Information obtained throughout this CERCLA investigation has identified contaminated landfill as the primary source type at the Carlstrom Landfill site. The contamination was found at various locations throughout the site and the area of contamination is estimated to be approximately 9.8 acres and includes the original pit area. The samples were collected around the perimeter of the land filled area and contaminants are believed to have migrated from the landfill. No samples were collected on the landfill since there was concern of penetrating the cap. This is the area within sampling points X103 – X104 – X106 – X107 – X108 – X109 – X110 – X103. See Figure 4 for sample locations.
